Lessons learned from Milagro

Outrigger Detectors

John A.J. Matthews

University of New Mexico

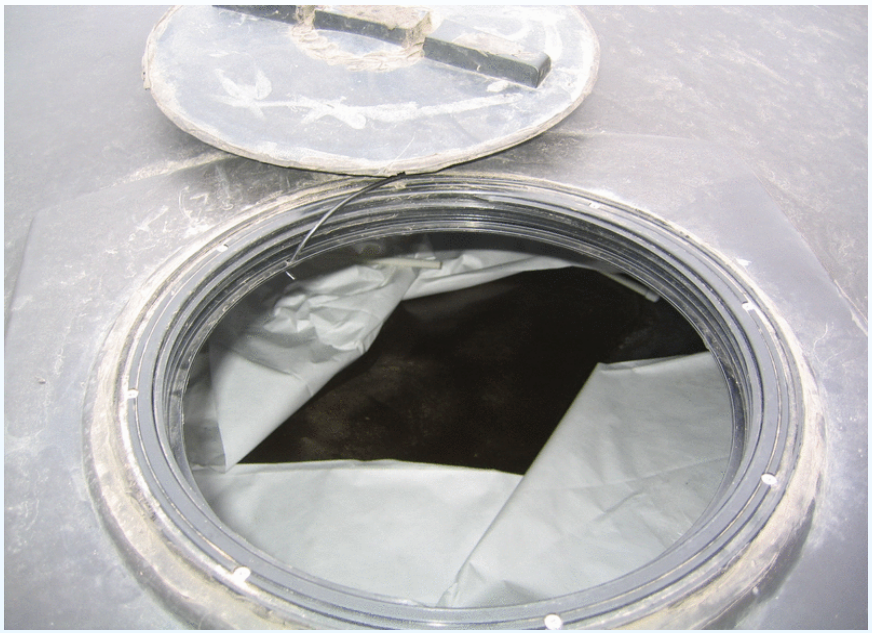
- **LEFT** photo of the 16” access port ... simple threaded design
- **RIGHT** photo of the HV and optical fi ber penetrations (through smaller 10” access port)
  PVC tubes cover threaded rods that support/position the PMT

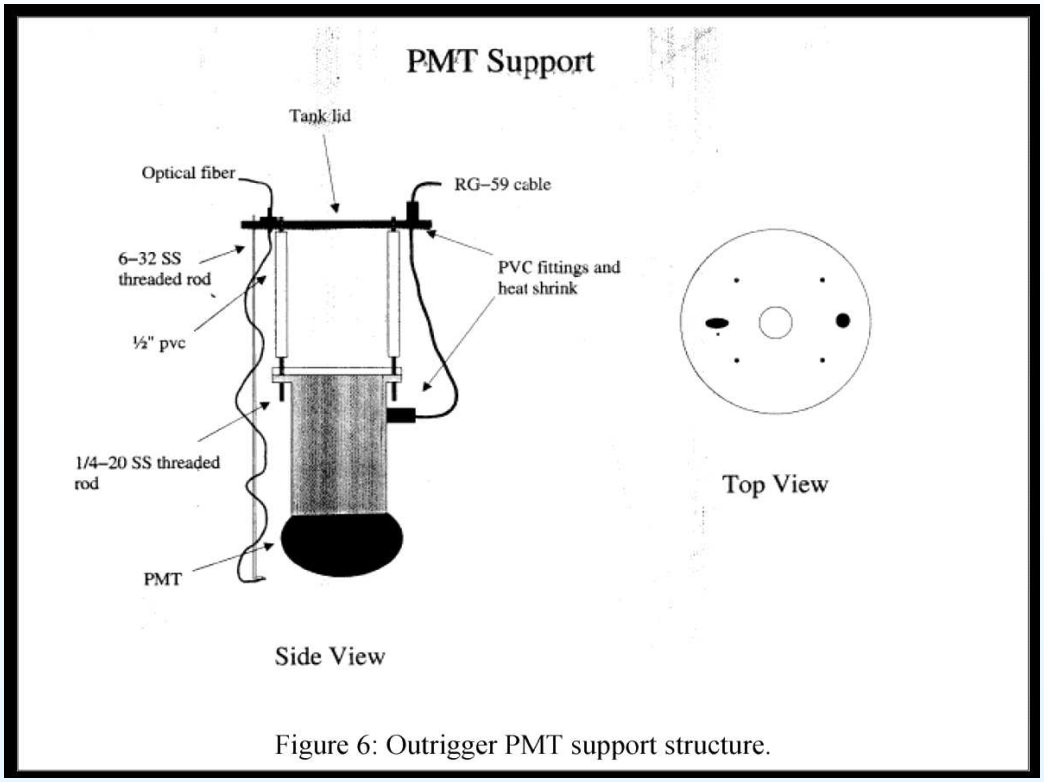
Figure 6: Outrigger PMT support structure.

- Water covers the PMT ... but not the entire PMT housing!
- Thus PMT base (electronics) subjected to extreme daily temperature fluctuations
- Some unhappiness with cable feed-through into PMT housing ...
- Ice formation has not damaged any PMTs (or effected the response significantly) but it has damaged the optical (calibration) fibers!

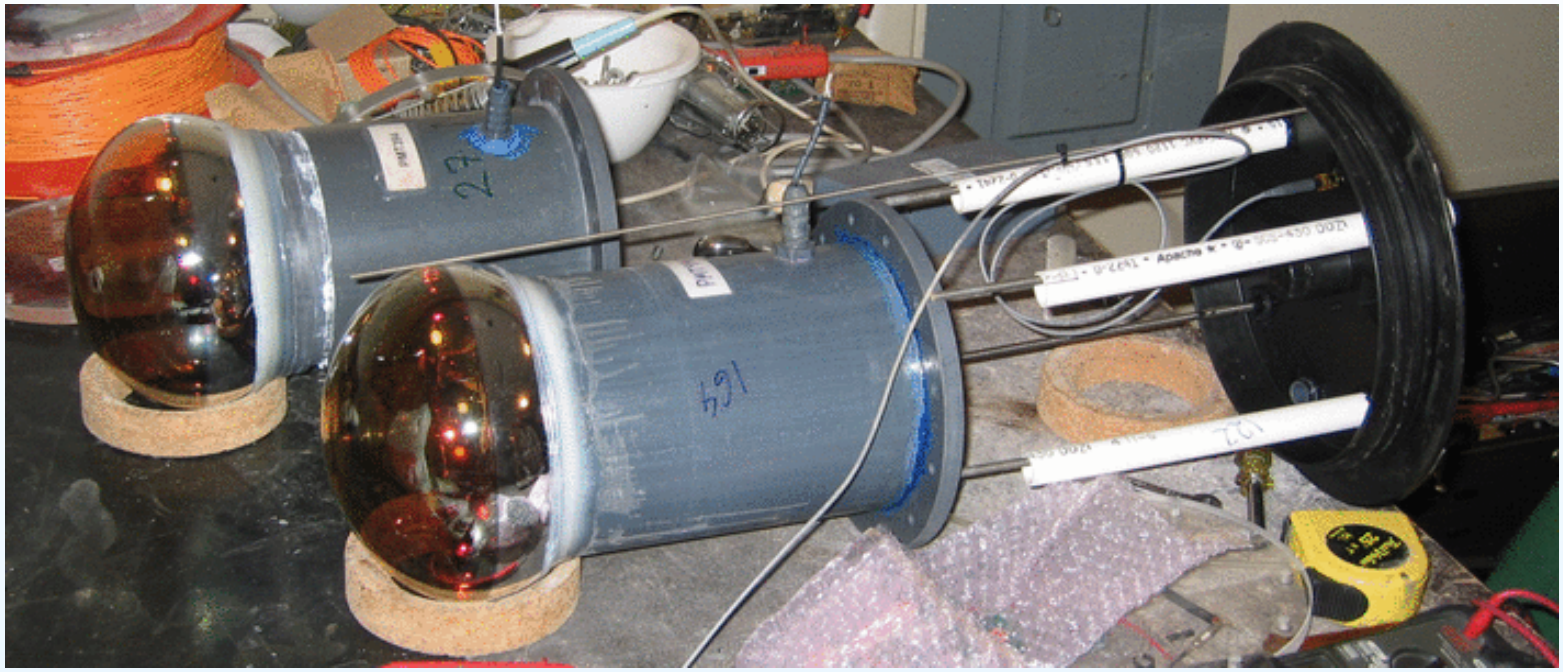
- PMT to PMT-housing sealed with RTV
- Water level visible a few inches above the RTV (by the 4 in the handwritten 164)
- Threaded rods position and support the *Milagro pond PMT housing* in the *outrigger* tanks!

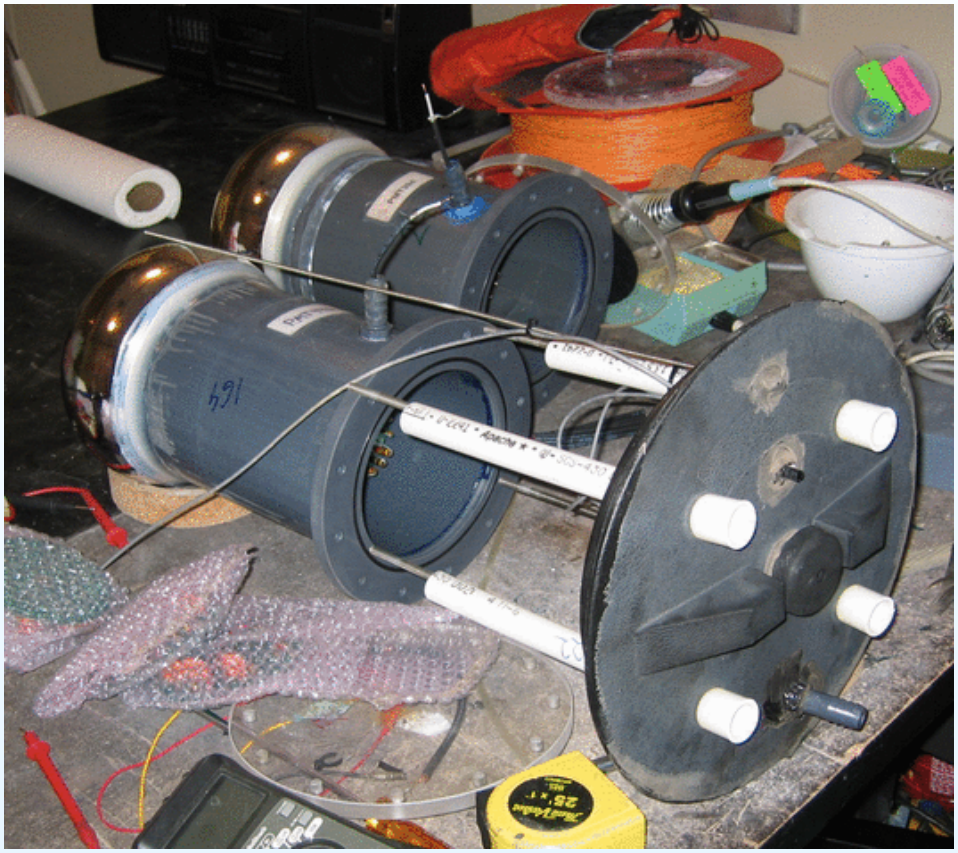
- Threaded rods connect to 10” tank access-port cover.
- Light leaks patched with black roof tar!
